RiteStart Home Inspections Home Inspection Report

1234 Main St, Orlando, FL 34711 Inspection prepared for: Sample Inspection Real Estate Agent: -

Date of Inspection: 7/23/2016 Time: 8:00 AM Age of Home: 1993 Size: 2702 Weather: Sunny Order ID: 77

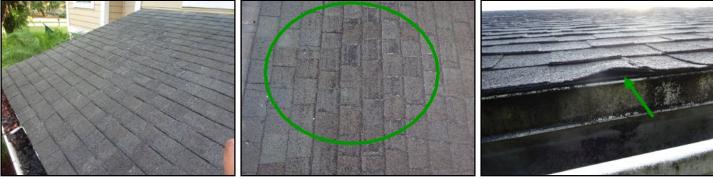
• No major system safety or function concerns noted at time of inspection. Patio has both metal standing and asphalt shingle roof covering this area. Recommend sealing the seams above the patio roof and monitoring the shingles as they are showing early signs of deterioration.

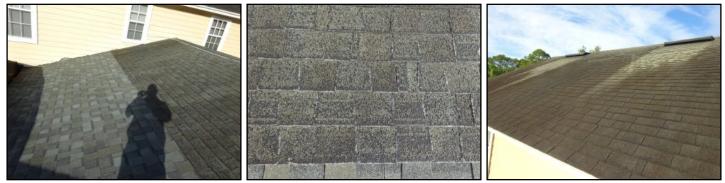
2.1		2011	antion		
Good	Margin al	Poor	Not Presen t	Not Inspect ed	Materials: Inspected on roof.
					Materials: Asphalt shingles noted.
	✓				Observations:
	•				 No permit information available online. Roof appears to be original from when home was built. Some sections have been replaced but not completely. At the time of the inspection, asphalt composition shingles covering the roof
					f this have a made to be seen the and of their working lives. The large start

oof of this home appeared to be near the end of their useful lives. The Inspector recommends that before the expiration of your Inspection Objection Deadline, you consult with a qualified roofing contractor to discuss options and costs for replacement.

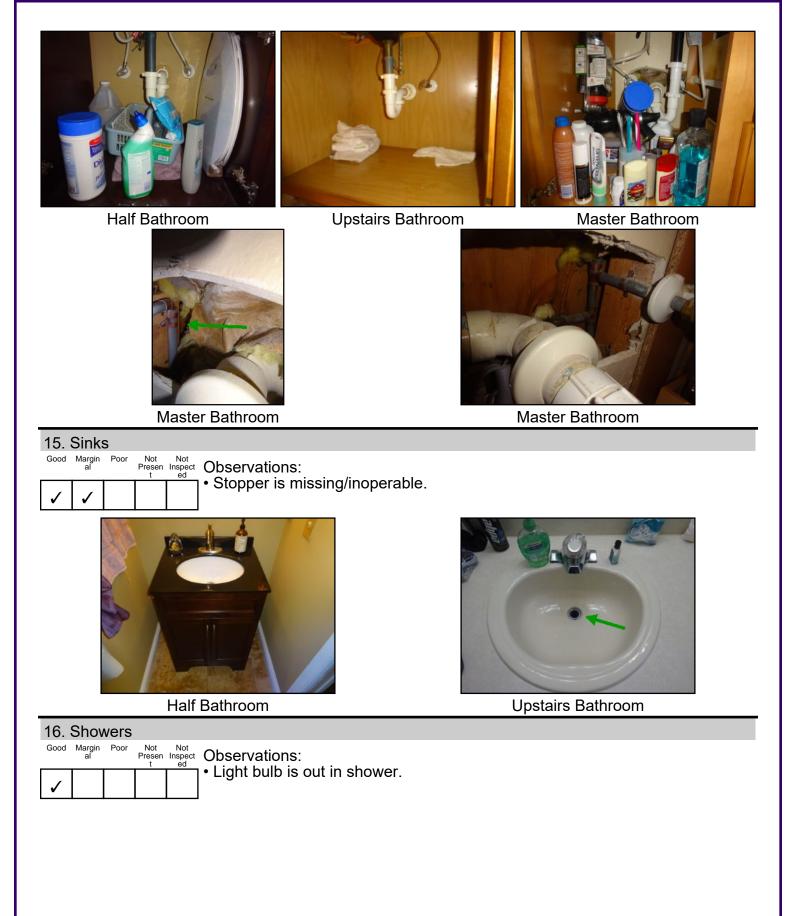
Master Bathroom

13. Mirrors	
Good Margin Poor Not Not al Presen Inspect	Observations:
✓	Mirror appeared in serviceable conditions at time of inspection.
14. Plumbing	
Good Margin Poor Not Not al Presen Inspect ed	Observations: • Master bathroom plumbing is exposed under sink. Polybutylene plumbing observed, no deficiencies found with plumbing but should be noted.
	Page 31 of 42
